Luckily for repairers, pulling the battery out of the Lenovo K5 Note is a simple task. Unfortunately, however, a broken display will require a bit of work for repair, thus yielding a repairability score of 6 out of 10.

Step 1 — Lenovo K5 Note Repairability Assessment

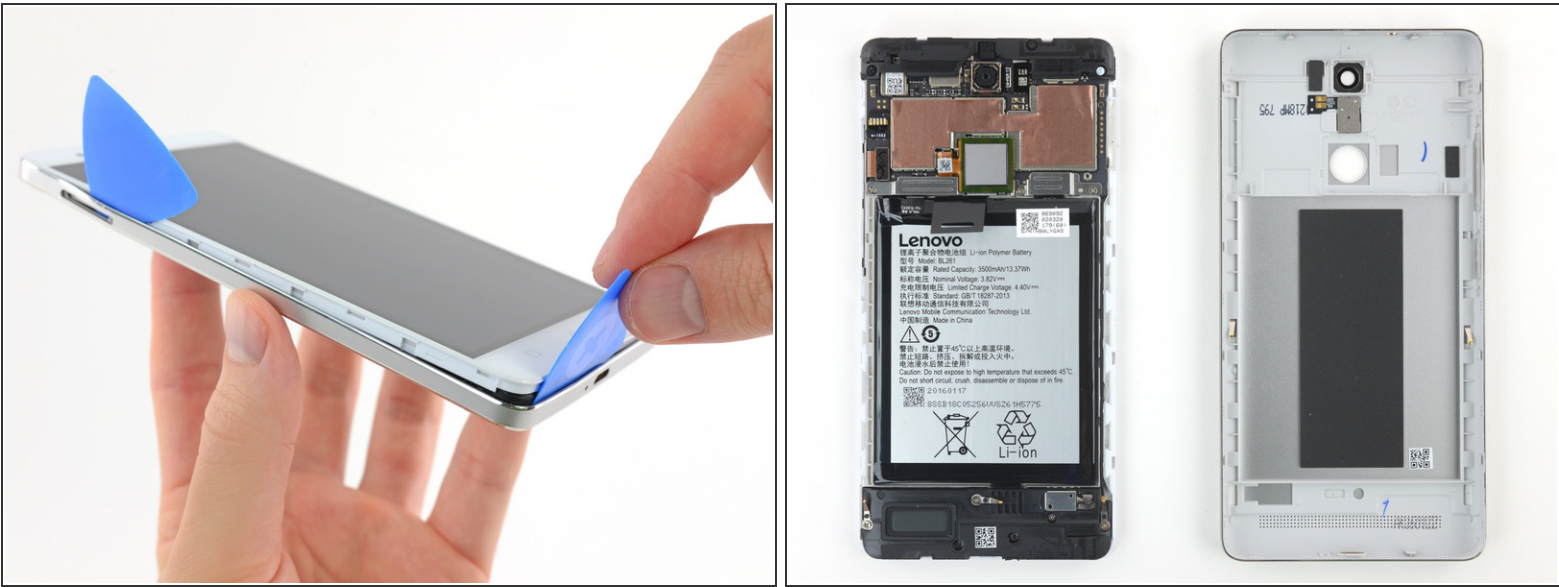
Step 2

- Rear case is a tight fit, but with the SIM card removed it pries off with determination and a couple picks. No screws or glue.
- Spring contacts connect the camera flash module and presumably some case antennas.
- Camera flash module is lightly adhered to the rear case.

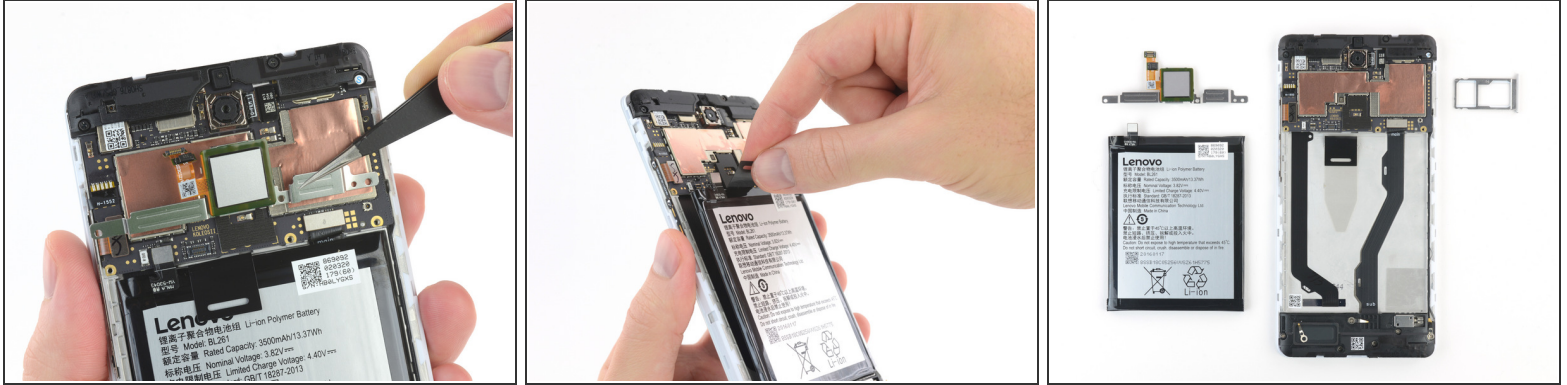
Step 3

- The battery connector is secured underneath a bracket attached to this fingerprint sensor. Three Phillips screws secure the bracket.
- Once the bracket's removed, there's a pull tab for easy battery removal.

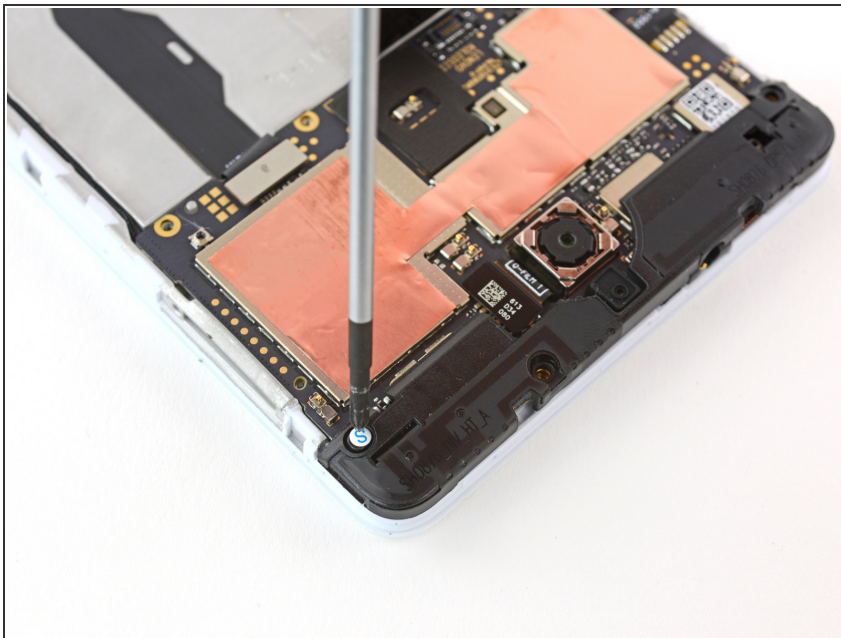
Step 4

- On the way to removing the motherboard we had to break through a tamper-evident sticker.

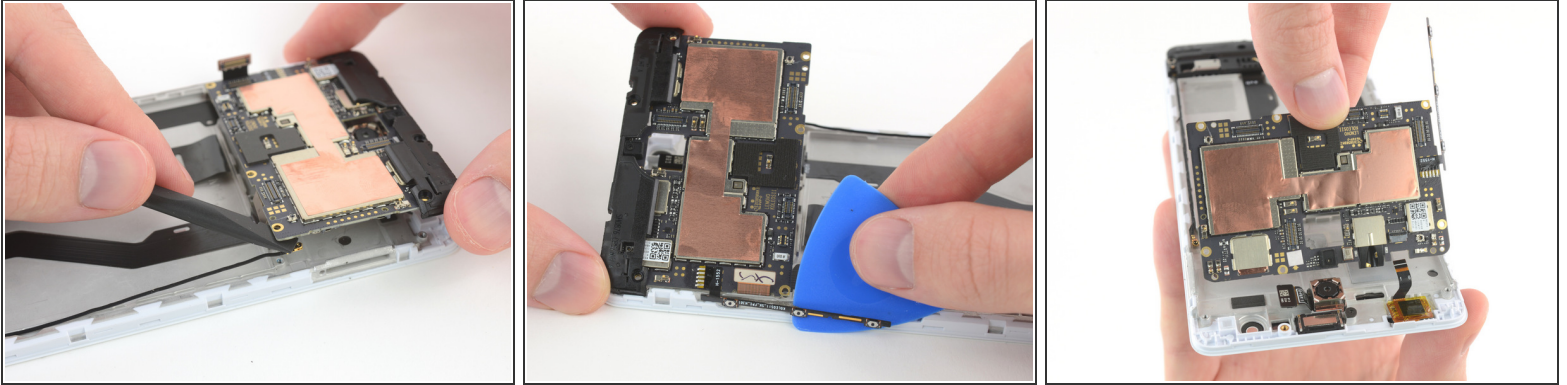
Step 5

- The motherboard is booby-trapped with cables on both sides.
- The power/volume button assembly is glued to the chassis and soldered to the motherboard.
- The headphone jack is soldered to the motherboard.

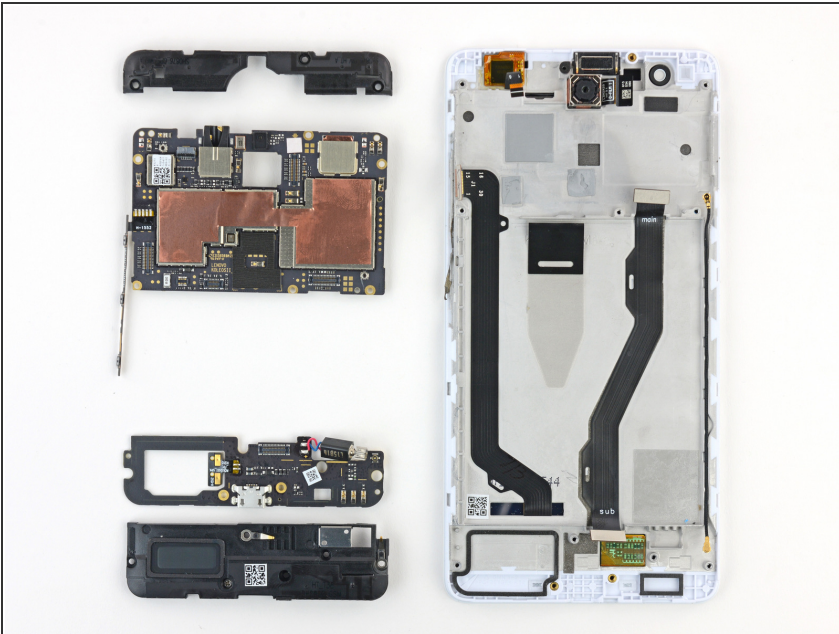
Step 6

- A handful of Phillips screws secure the daughterboard—all the same size.
- The vibrator motor is soldered to the daughterboard.
- The primary speaker connects by way of spring contacts.

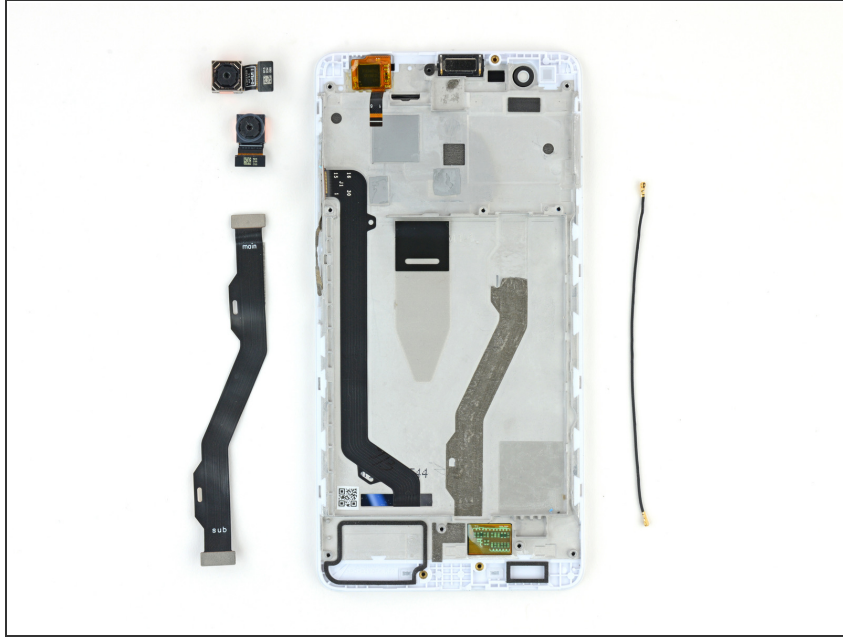
Step 7

- The primary camera is firmly glued to the midframe. It might be possible to extract it without first removing the motherboard, but only with some risk of pry damage to the motherboard.
- The selfie camera is installed on the back of the motherboard, requiring removal of the motherboard for access.
- Both cameras are modular.
- With the interconnect cables out, this is as far as we go. The display looks to be firmly secured to a mid-frame for rigidity and would be impractical to separate. While it's the most likely component to break, everything else mounts to it—making it effectively the last component to be removed.
